Shearpin Failure Trouble-Shooting Guide

SE30, SE40, SE60

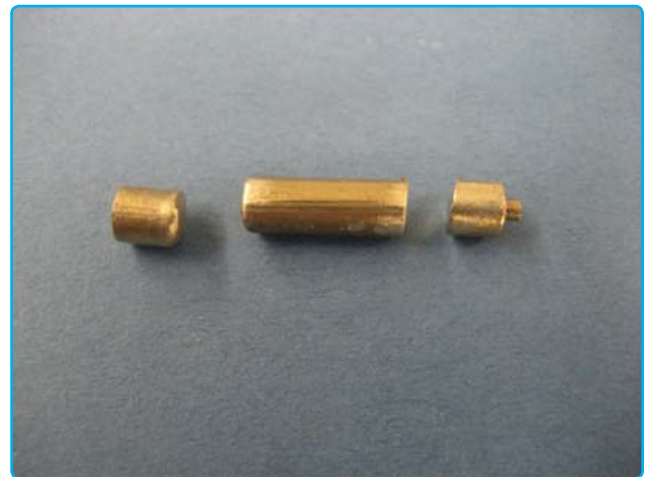
Normal Breakage:

In the event of a break due to a tunnel obstruction the shearpin will break into three clean pieces.

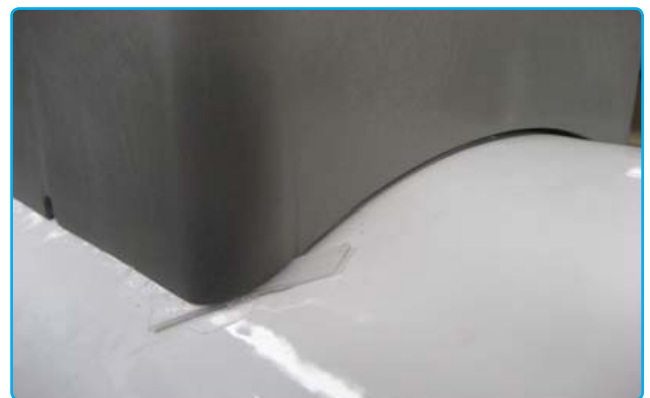
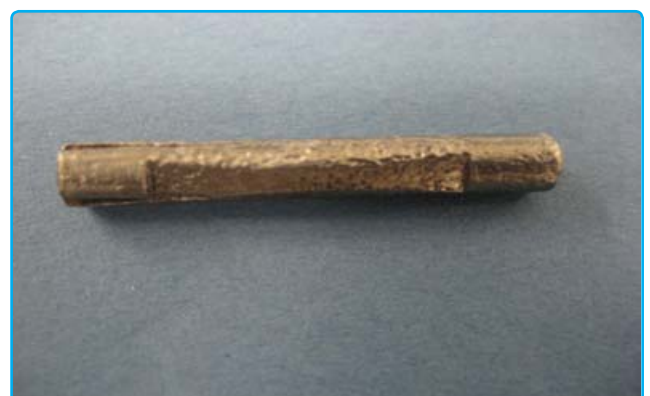
Motor Bracket Miss-Alignment:

If there is fiberglass or paint build up on the tunnel under the motor mounting bracket then a miss alignment of the gearleg shaft and motor shaft will occur. This will cause the shearpin to move up and down in the gearleg shaft u-slot as it rotates wearing it down in four spots.

The shearpin here shows premature wear due to bracket miss-alignment. There are identical wear spots not seen in photo on the opposite side of the shearpin.

All tunnel build up must be removed in order to eliminate reoccurrence of this failure. Please contact your Side-Power distributor for further detail.

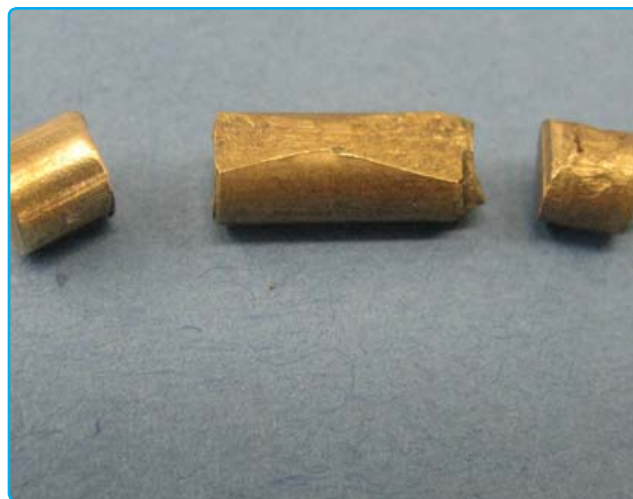
Shown here is a shearpin worn from bracket miss-alignment after breakage. Metal fillings will be seen on the top of the gearleg in the event of this type of failure.

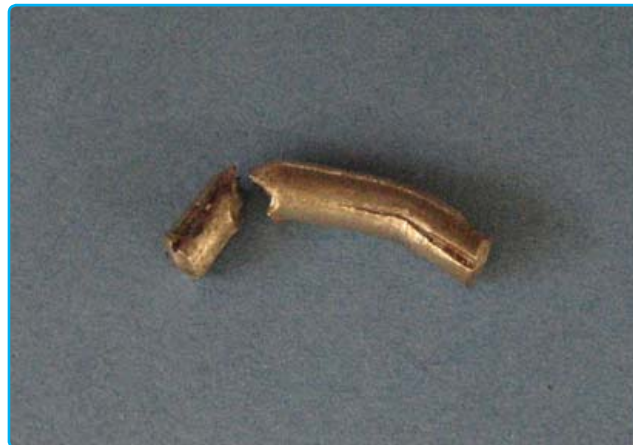
If the gearleg height is too high then the shearpin will be bent when the motor is tightened down on the motor bracket.

Contact your Side-Power distributor for details for further detail to achieve proper gearleg shaft height.

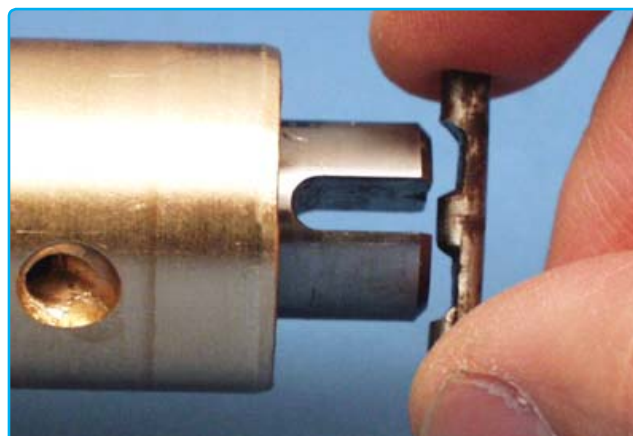
If the gearleg shaft is too low then the shearpin will not fully engage, the shearpin will be partially worn through as shown here.

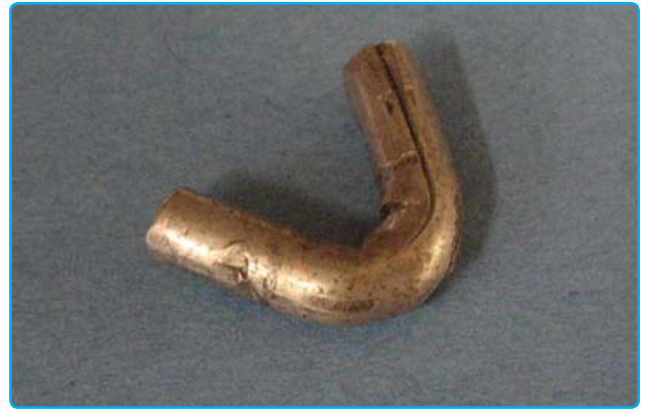
Shearpin slipping out of motor shaft:

If the shearpin pulls out of the motor shaft it will get bent into a u-shape as it hits the gearleg mounting bolts as it rotates.

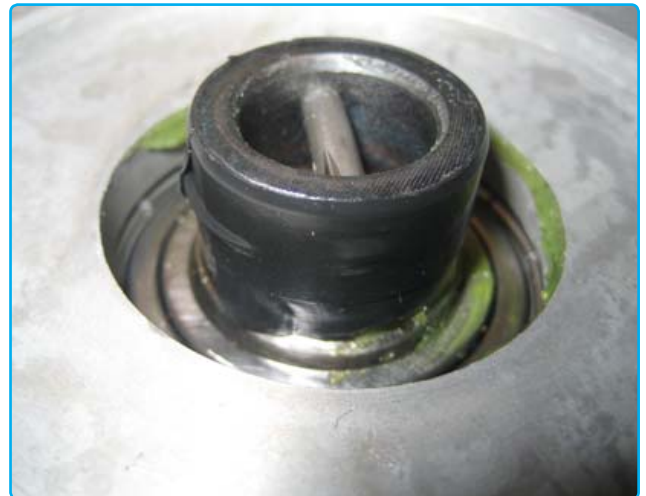
The SE60 model shearpin is held in place by means of a friction fit. It is possible that after repeated shearpin breakages that the shearpin holes in the motor shaft get enlarged such that the shearpin is no longer being held firmly in place. In this situation the shearpin can be simply held in place by wrapping tape around the motor shaft/shearpin after installation.
