W.S.67/16 SERVICE KITSET (INC. PARTS NO.5,6,11) (NOT PICTURED)

WS 67 Repair Instructions

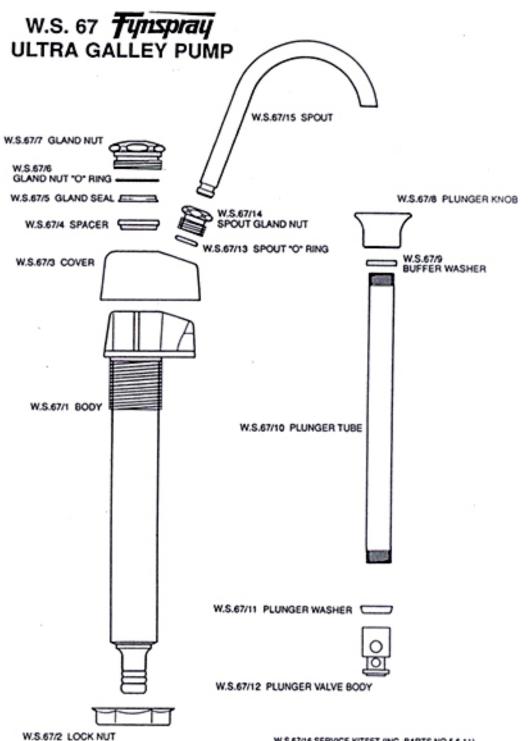
To replace the plunger washer (#11) - Loss of suction.

To replace the gland seal (#5) - Leaking of the gland.

Unscrew the gland nut (#7) which enables the complete plunger assembly to be removed. Check that the plunger washer (#11) is soft & pliable and that it is a push fit inside the pump barrel. If it is not a push fit and/or is cracked it must be replaced.

Having removed the complete pump assembly (as above) unscrew the plunger valve body (#12) (earlier models unscrew the plunger knob (#8). DO NOT HOLD THE PLUNGER TUBE IN ANY TOOLS AS THEY MAY CAUSE DAMAGE. When replacing or removing the gland seal onto the plunger wind it in the direction of the plunger thread so as not to damage the lip edge.

The gland nut 'o' ring (#6) is also included in the Service Kitset and whether replaced or not should be lubricated with a little vaseline.

Note that both the gland nut (#7) and the spout gland nut (#14) should not be overtightened.
