Sleipner Tunnel Thrusters

DRIVE CONNECTION/COUPLER PRODUCT INFO SHEET

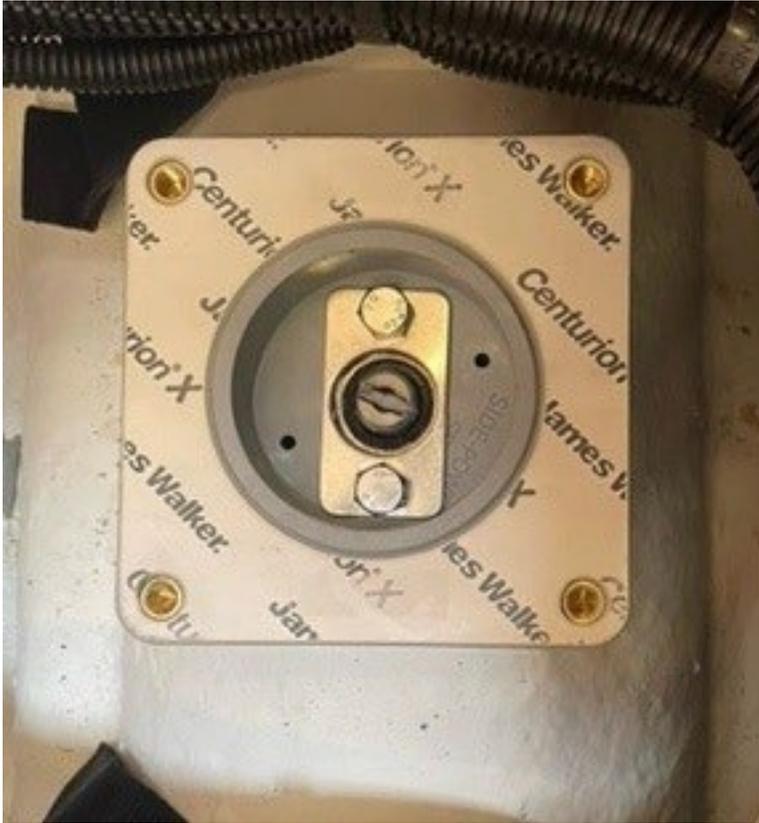
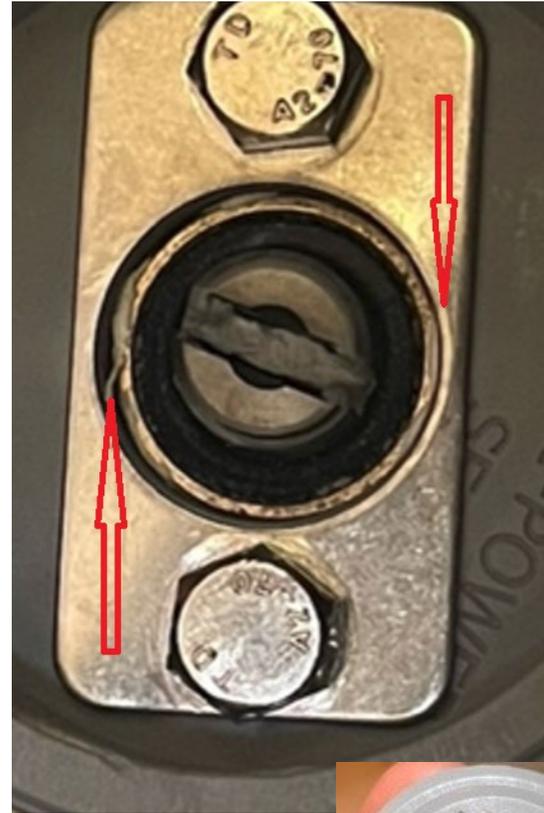
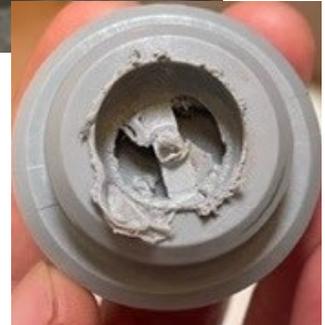
Tunnel with build-up and looking at the gearleg in the motor mount one side of the bronze throat is higher than the other and there is also sealant present which is also a flag for assembly mistake.

The result of misalignment is premature wear of the drive coupler, and it will break depending on use and not as the product was intended. Damage to a coupler or any resulting damage to any other components or equipment, is not covered under the product warranty.

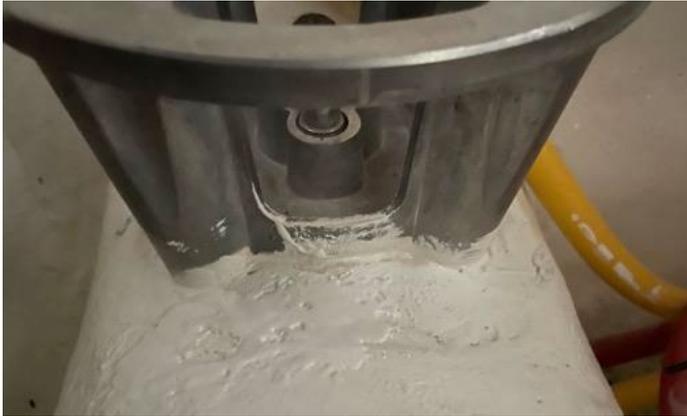
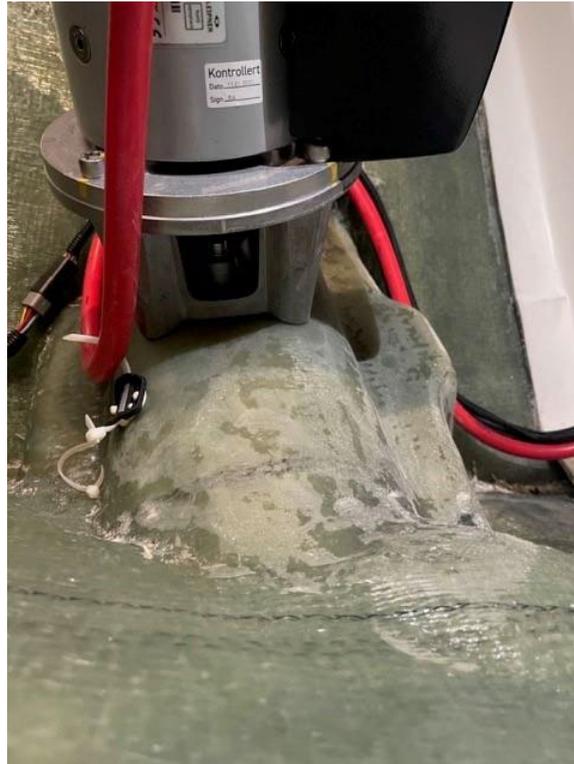
Examples of Tunnel with build-up and Hull molded tunnel. You can inspect the gearleg in the motor mount and also shaft alignment from the sides.

The result of misalignment is premature wear of the drive coupler, and it will break depending on use and not as the product was intended. Damage to a coupler or any resulting damage to any other components or equipment, is not covered under the product warranty

- The motor mount bracket is open, so you can check alignment and engagement looking in from the side. With the coupler off, visually check alignment with a straight edge.

- You can also visually check alignment by looking at the gearleg throat and driveshaft in the center of the motor mount bracket to see if it is raised on one side causing alignment issue, or if the gearleg is too low, or too high in the motor mount causing engagement issue.

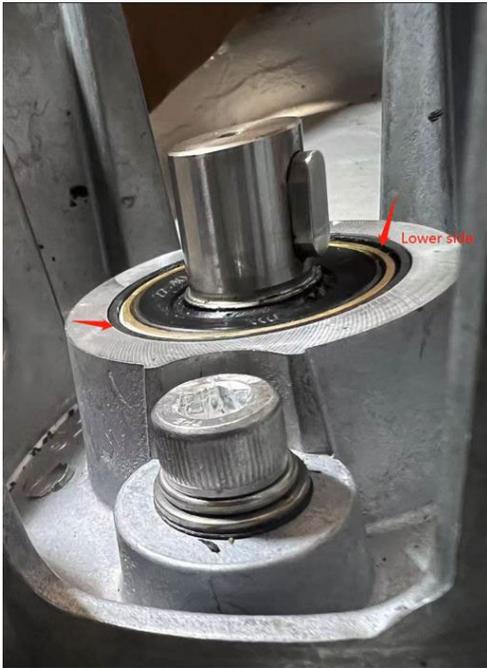
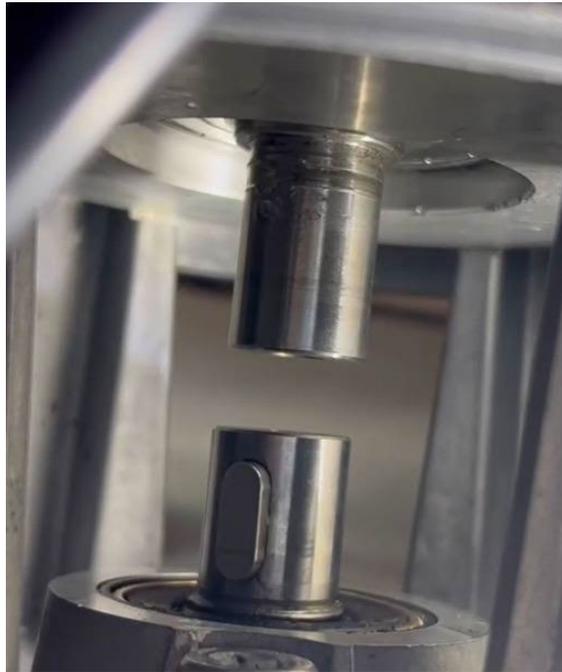
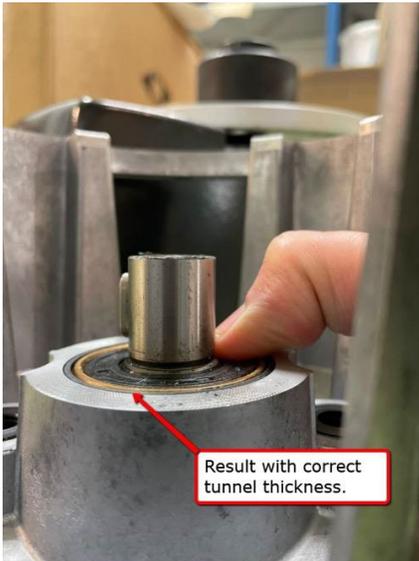
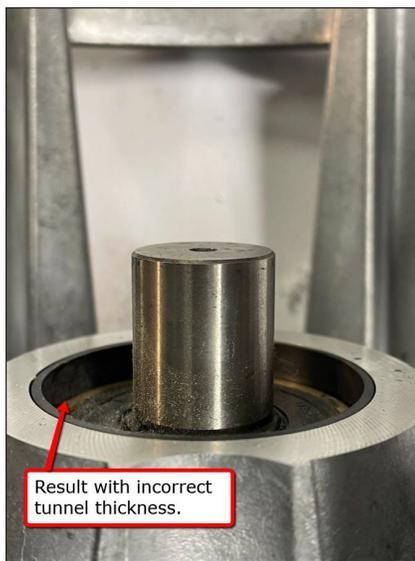
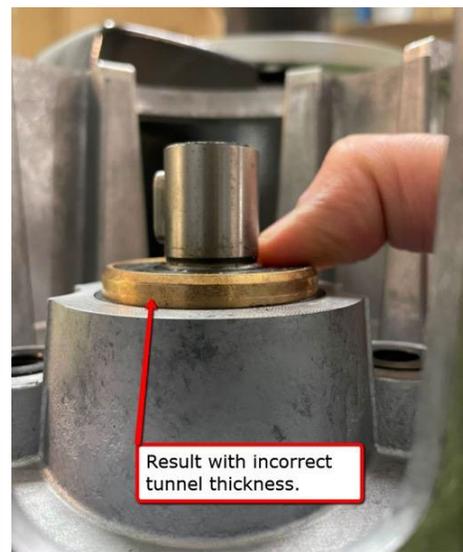
Examples of misalignment and visual signs when looking at gearleg in the Motor Mount Bracket.
