Shearpin Failure Trouble-Shooting Guide

SE30, SE40, SE60

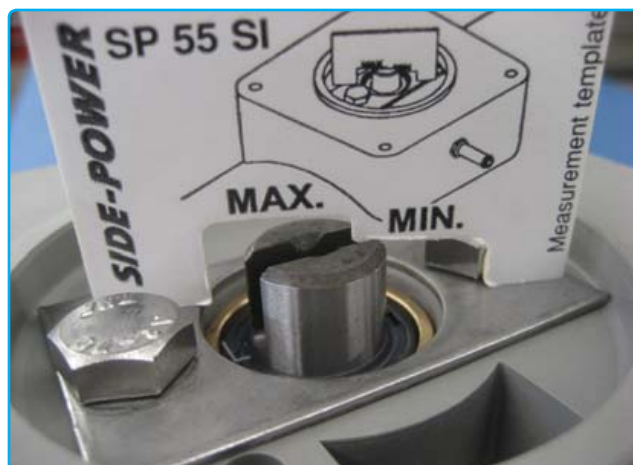
The gearleg shaft height must be within specification in order for the gearleg to engage properly. A gauge is supplied with the thruster to measure correct gearleg shaft height.

Additional gauges can be obtained through your Side-Power distributor.
