***SIDE-POWER* - Prop fitting addendum – older 4 & 7HP**

Ref. technical information sheet dated May 12, 1995

SUBJECT : Installation of plastic propellers SIDEPOWER

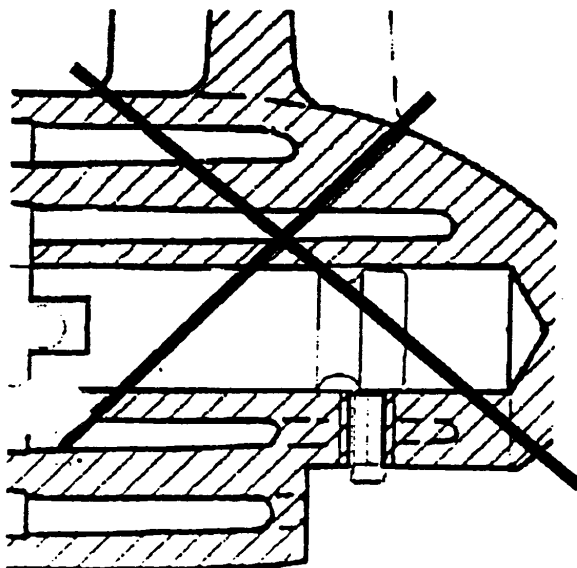
FIG 1 wrong

REASON : The problem is caused by the propeller never being correctly fastened. If the propeller have not been pushed all the way in, the set screw (#1) fastened in its treaded hole (#2) in the propeller (#3) does not come in to the lock track (#4) on the propeller shaft (#5) so that it is only pushing against the flat shaft. (SEE FIG.1.) This can hold the propeller for a short while, even when the thruster is being run the way that drags the propeller from the shaft, but the propeller will fall off sooner or later. So this is nothing but an installation mistake.

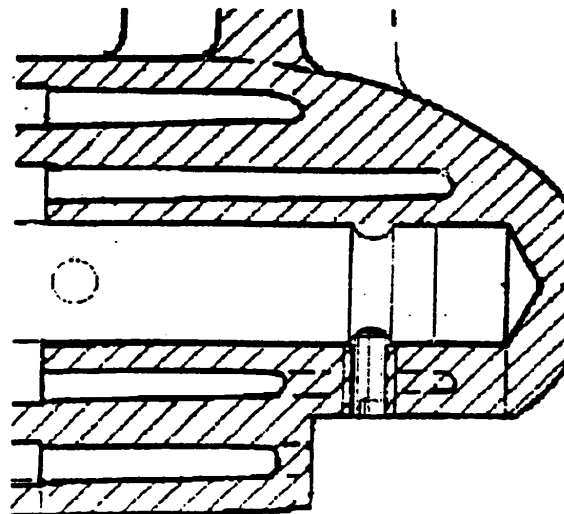
FIG 2 right

SOLUTION : - Install the propeller correctly on the shaft (SEE FIG.2).
- To make it easier to be sure that the lock screw is correctly in the track, we now supply head-less screws that must be all the way in to the hole for the installation to be correct.

Please also make sure that the drive pin is in the propellershaft and also that it is centred.

WARE! There are plastic threads in the propeller, so do not tighten the screw to hard.

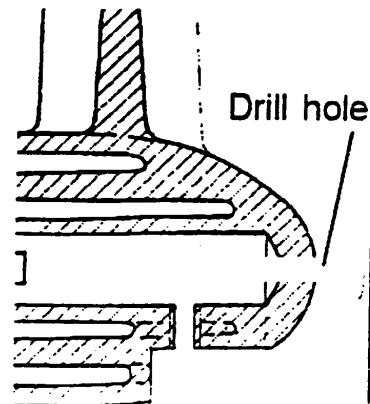
FIG 3 for installation under water or on wet shaft

PS! When a propeller have been damaged, many people does not want to lift the boat out of the water, so they dive to put on the new propeller. This is OK, as long as it is being pushed all the way on to the shaft, which is very difficult under water, as the propeller and propellershaft fits eachother perfectly, so you will compress water inside the propeller that makes it impossible to push the propeller all the way in on the shaft. To avoid this problem, drill a hole in the end of the propeller to let the water come through. (SEE FIG.3.)

When fitting an old 3-blade prop on a 4HP or 7HP unit in the water, it is necessary to drill a small hole through the nose of the prop to allow displacement of water when fitting the prop onto the prop shaft.
